Manhole Inspection Summary

Manhole # S53I__012MH

Insp Date: **5/27/08 9:15 AM**

Location Address: **401 s ellwood ave**

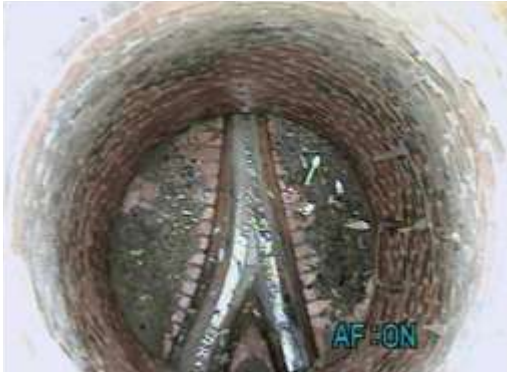
Defect 2

Condition: ☐ Sound ☐ Cracked ☐ Root Intrusion ☐ Deteriorated ☐ Leaks ☒ **Debris**

debris

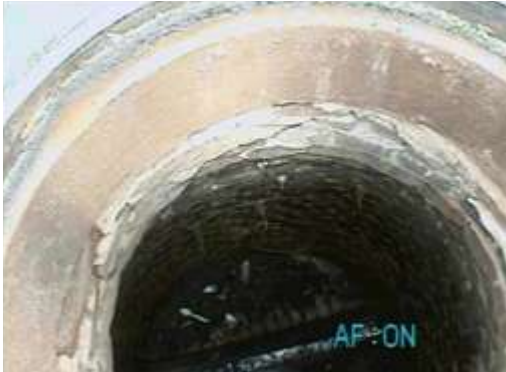
Defect 1

Count: **4** Missing: **3** ☒ **Corroded**

steps

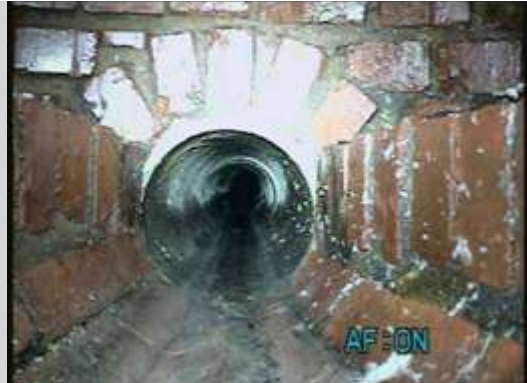
12 O'Clock Outflow

8 in. Circular Gravity Sewer
Pipe Out @ 12 OClock

Pipe Material: **Clay** ☐ Pipe Lined

Invert Depth: **9.20** (ft.) Flow Characteristics: **Fast**

Infiltration: **None** Pipe Seal Cond: **Unknown**

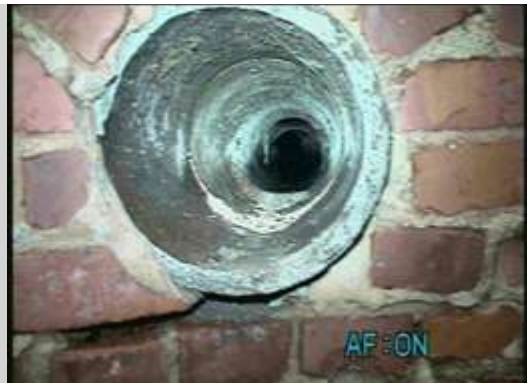
5 O'Clock Inflow

8 in. Circular Gravity Sewer
Pipe In @ 5 OClock

Drop In @ 5 OClock

Drop: **Outside Direct**

Drop Condition: **Open**

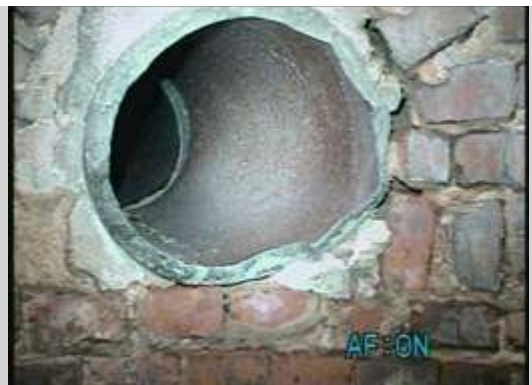
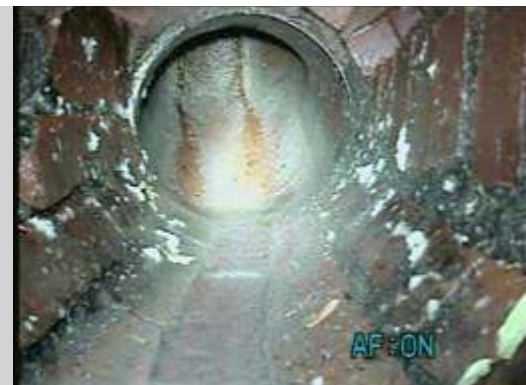
7 O'Clock Inflow

8 in. Circular Gravity Sewer
Pipe In @ 7 OClock

Drop In @ 7 OClock

Drop: **Outside** Direct

Drop Condition: **Open**
